Cohasset Town Hall
Cohasset, MA
HVAC Existing Conditions Systems Report
J#732 006 00.00
L#56566/Page 1/May 23, 2017

HVAC

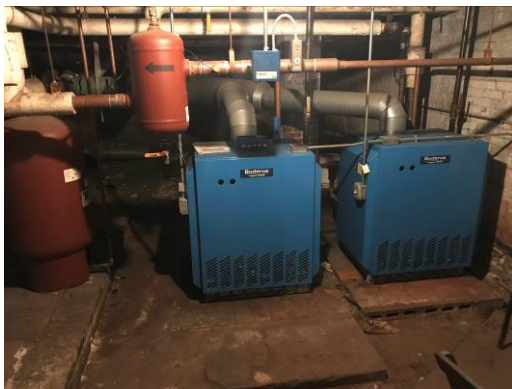
The original Town Hall building and Addition building are primarily heated by a gas fired hot water plant that is located in the basement. The boiler plant consists of two standard efficiency gas fired boilers, in line pumps, hydronic accessories (expansion tank and air separator), controls and steel/copper piping distribution system. The boilers were installed approximately 15 years ago and were manufactured by Buderus (Model Logano G334). The boilers each have a capacity of 542 MBH input, 451 DOE rated output, and 392 MBH Net I-B-R output; and combustion efficiency of 83.4%. Required boiler safety devices including low water cutoff, boiler safety fuse-o-matic switch and burner switch are installed. The boilers are vented through the use of galvanized steel un-insulated breeching that is routed from the boilers to masonry chimney. The breeching appears to be in fair condition, but shows some signs of corrosion.

Existing Hot Water Boilers, Expansion Tank & Air System

- The existing original building and addition HVAC systems are generally in poor condition and in need of replacement and upgrades in terms of energy efficiency, thermal comfort, acoustics and improved indoor air quality.
- The existing boiler plant has a lower efficiency than current high efficiency boiler plants, and is nearing the end of its expected service life of 20 years. We recommend that the existing boiler plant be replaced with a high efficiency gas-fired condensing boiler for improved energy savings. New boiler breeching and combustion air ductwork should also be provided. New hot water pumps equipped with variable flow VFD drive or ECM motors and associated controls should be provided for additional energy savings.

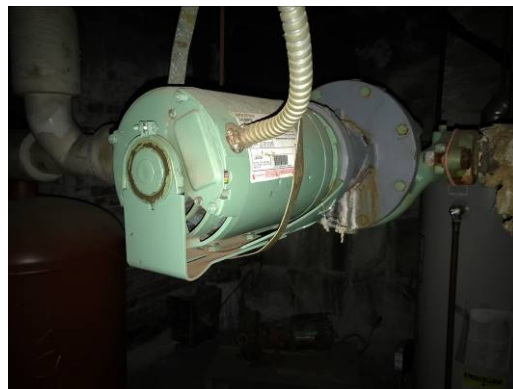
There are two in-line hot water pumps installed in the basement boiler room. One pump serves the original Town Hall building's heating system and the other pump serves the Addition building's dual temperature heating and cooling system. The addition building pump was manufactured by Bell& Gossett and appears to be in good condition, while the original building hot water pump was manufactured by Taco, and appears to be in poor condition. Neither of the pumps are equipped with VFD (variable frequency drives) drives or ECM motors.

Hot Water Pump (Taco)

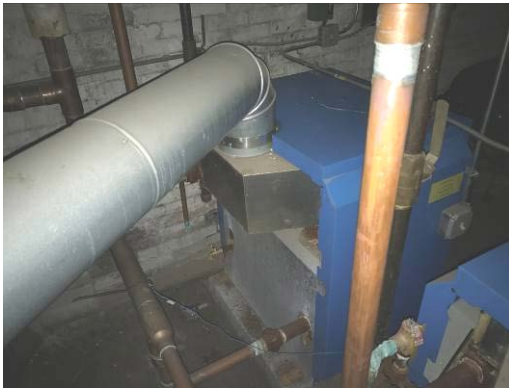
Boiler Breeching

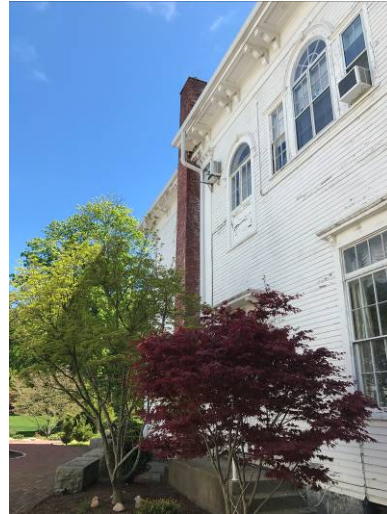
Boiler Chimney

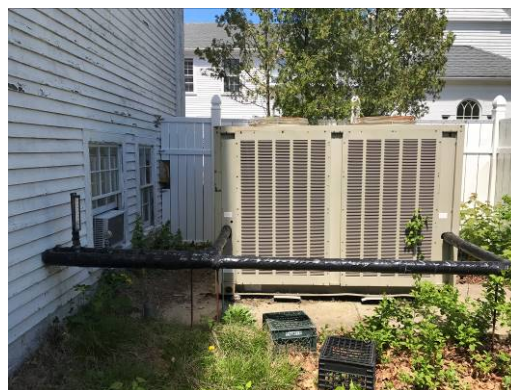
The Addition building is air primarily air conditioned by an outdoor grade mounted chiller that is located behind the building within a fence enclosure. The chiller was manufactured by Trane (model CGACC30, R-22 refrigerant) and has a nominal capacity of 20 tons. The Chiller was installed in 1988, is approximately 29 years old and is beyond its expected useful service life of 20-25 years. The chiller casing and fan guards are rusted in areas. Chilled water is distributed from the chiller to building fan coil units by a dual temperature in line pump that is connected to an insulated steel and copper insulated piping system.

Outdoor Air Cooled Chiller

- The existing Addition building Chiller is past its useful service life and has a much lower efficiency than high efficiency models that are commercially available today. The existing chiller also does not have capacity to air condition the entire building complex. Therefore we would recommend that a replacement chiller is sized to provide chilled water for the entire building complex.

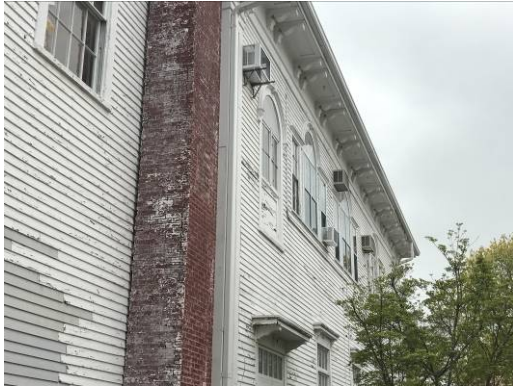
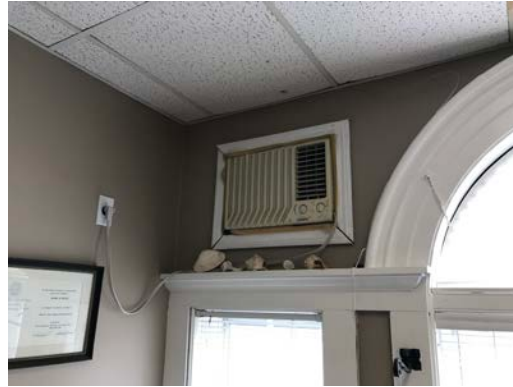
The original Town Hall building offices are primarily air conditioned by window air conditioning units. There are also some window AC units located in the dressing room areas of the Auditorium. The window AC units generally appear to range from fair to poor condition. The Auditorium is not air conditioned.

Window AC Units

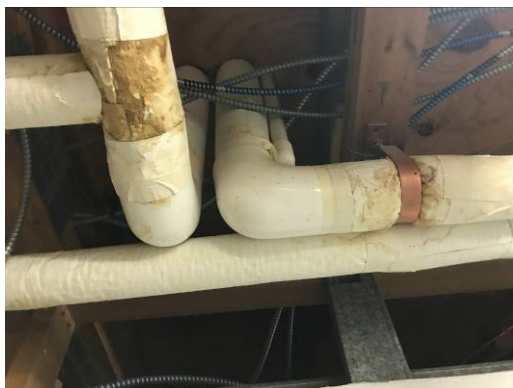
The two-pipe change over piping distribution system that serves the Addition building was installed circa 1988, and appears to be in fair condition. The piping is approximately 29 years old and nearing the end of its expected useful service life of 30 years. Many sections of piping insulation, particularly in the basement and Auditorium dressing room appears to be in poor conditions and showing signs of water damage from condensate occurring on the exterior surface of the piping and possible small pipe leaks which may have occurred in the past. Some piping hangers are also corroded due to direct contact with piping.

Damaged Dual Temp Piping Insulation

- Existing hot and dual temperature piping and terminal heating/cooling equipment (fin tube radiation, convectors, fan coil units and unit heaters) should be removed and replaced with a new 4-pipe insulated hot water, chilled water piping distribution system and terminal heating and cooling equipment.

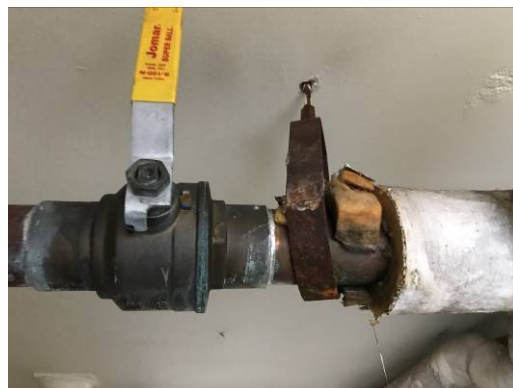
Chilled Water Piping Missing Insulation

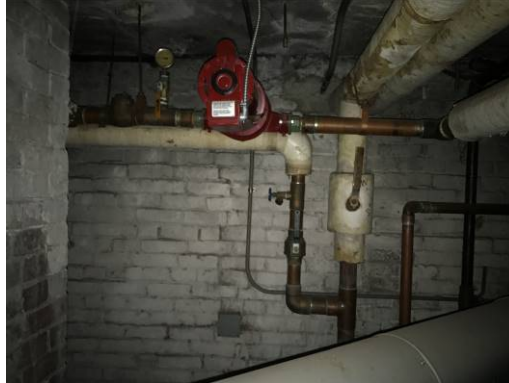
Dual Temperature Pump

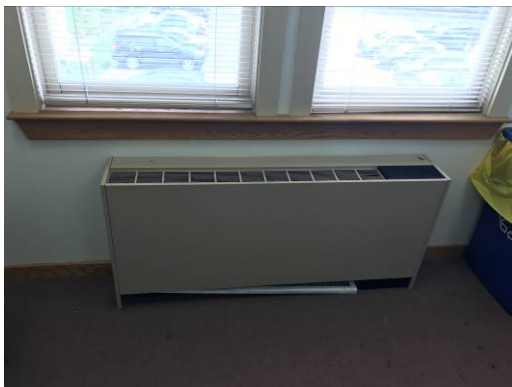
The Addition building offices, corridors, and meeting rooms are heated and air conditioned by 2-pipe hot water-chilled water change-over fan coil units. The fan coil units were installed circa 1988 and are 29 years old. The units appear to range from fair to poor condition. In total, there are approximately 21 fan coil units. Approximately 20 units are vertical console type fan coil units. One horizontal blower fan coil unit serves the corridor and copy /file room areas located on the first floor of the Addition building. Some areas of the building are heated by hot water fin tube radiation heating equipment.

Addition Fan Coil Unit

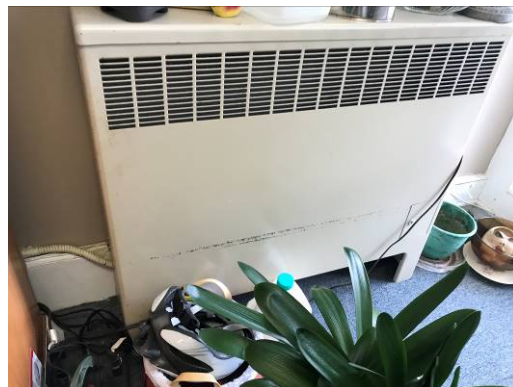
The original Town Hall building offices and the Auditorium are heated by hot water radiators. The radiators appear to have been installed prior to the construction of the Addition building. Therefore the equipment is older than 29 years, and has exceeded its expected useful service of 25 years. The radiators generally appear to be in poor physical condition. The main entryway of the Auditorium does not appear to have sufficient heating.

Original Building Convector Radio

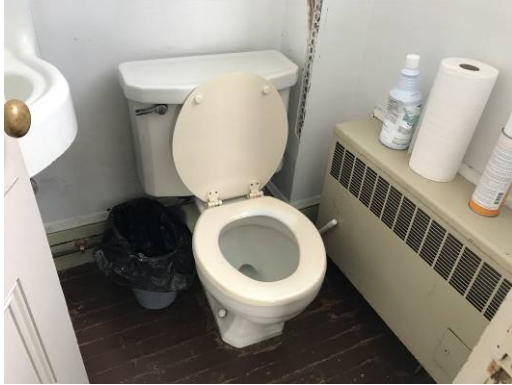
The restrooms in the original and addition areas of the building are heated by a combination of hot water fin tube radiation and convector radiator heating equipment. The majority of this equipment is in poor physical condition.

Restroom Convector

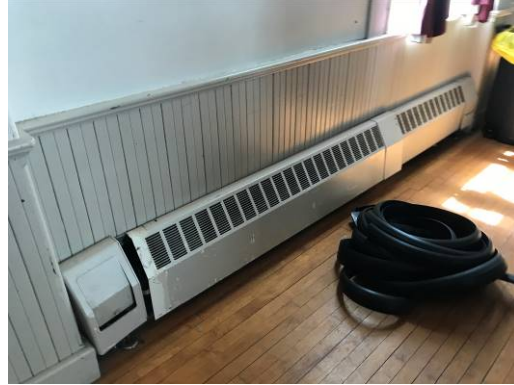
Auditorium Fin Tube Radiation

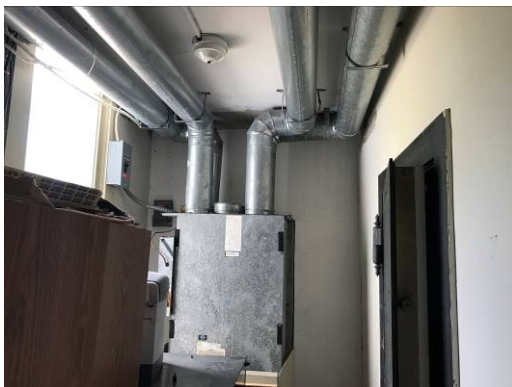
There is a thru wall ventilation and air conditioning unit installed in on the second floor of the original Town Hall building. The unit was manufactured by Carrier (model 50QT224300, R-22 refrigerant). The unit appears to be inoperable and in poor condition.

Thru-Wall AC Unit

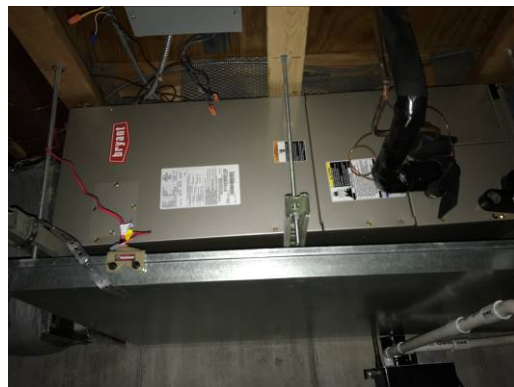
The Addition basement and first floor Vault rooms air conditioned by (2) split system air handling unit with associated supply and return ductwork and in-duct electric steam generating humidifier. The indoor units are connected with refrigeration piping to (2) outdoor grade mounted condensing units that are located adjacent to the Chiller. The basement vault AC unit was manufactured by Bryant, and has an associated 1.5 Ton outdoor R-22 air cooled condensing unit that was manufactured by Ameristar (Model PA13NR018). The indoor and outdoor units appear to be in good physical condition. Some sections of the vault ductwork insulation appear to be damaged and in need of repair or replacement. The first floor vault AC system indoor and outdoor units are believed to have been installed in 1988. The outdoor unit appears to be in poor condition.

Basement Vault AC Unit

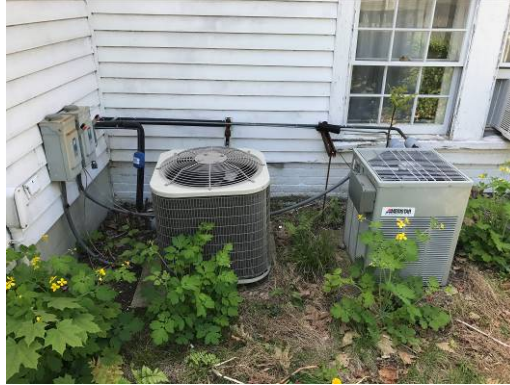
Air Cooled Condensing Units

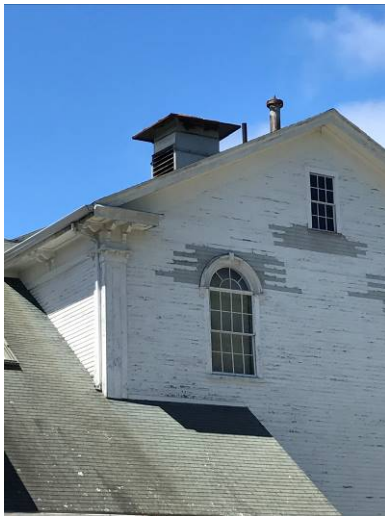
The original Town Hall building is primarily ventilated through the use of natural ventilation by use of operable windows and a whole building exhaust ventilation ductwork system. Several of the restrooms did not have mechanical ventilation systems installed. There is an exhaust turbulator system installed which appears to exhaust some rooms in the original building. However, this system appears to be in poor condition and in need of replacement and upgrades. The Auditorium dressing/storage room exhaust ventilation systems are not operable, and need replacement. The Auditorium does not appear to have a mechanical ventilation system installed.

*Original Town Hall Turbulator Exhaust (right)
and Louver (left)*

- Mechanical ventilation should be provided to all occupied areas of the building by new indoor air handling units equipped with energy recovery, hot water heating, chilled water cooling, supply and return fans and filters. Potential locations for air handling equipment include the basement and Attic areas of the building.

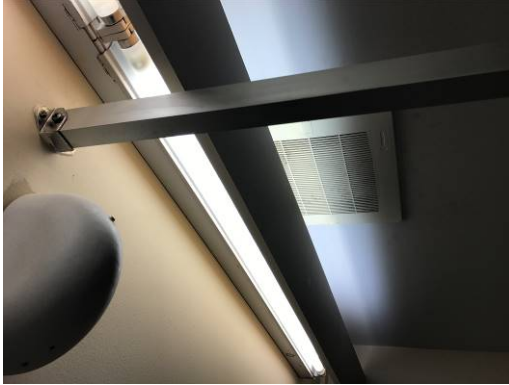
Toilet Room - Ceiling Exhaust Fan

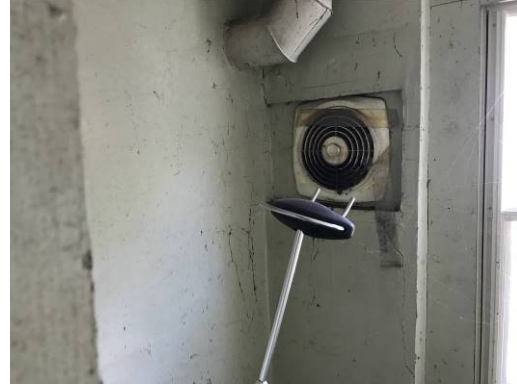
Auditorium – Dressing Room Exhaust Fan

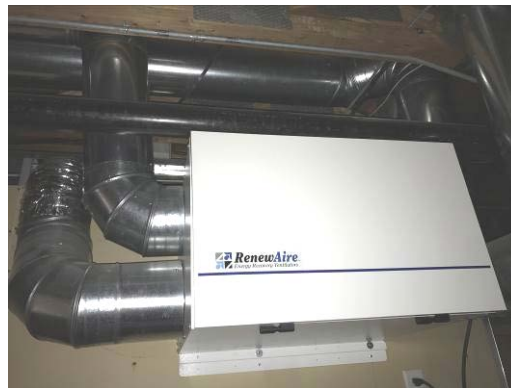
The basement Addition meeting room is ventilated by a static plate type energy recovery ventilation unit that is installed in the basement. The unit is a ceiling suspended horizontal model manufactured by RenewAire. The unit is operated by a wall mounted switch located in the meeting room.

The unit and associated ductwork distribution appears to have been installed in recent years, and appears to be in good condition.

Meeting Room ERV Unit

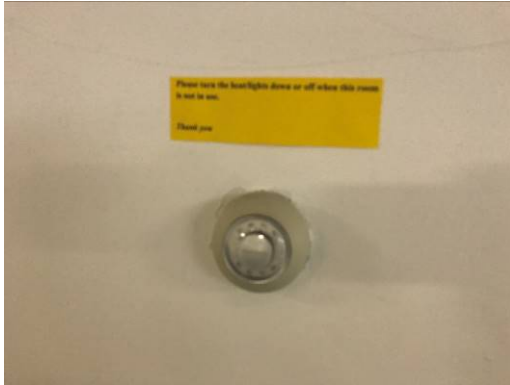
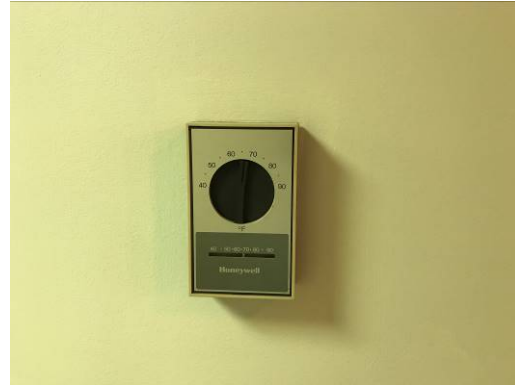
The original building heating system is controlled by wall mounted thermostat and hot water valve controls. The controls are electric. The Addition building heating and cooling systems are controlled by wall mounted thermostats. The HVAC heating and dual temperature pumps are controlled by a Taco Relay controller.

Room Thermostats

- The existing HVAC control system including thermostats, relays, control valves/dampers and wiring should be replaced, and a direct digital control (DDC) system should be provided to control all newly installed HVAC systems. The DDC system will provide energy savings by managing the HVAC system. The DDC system will control space set points, reducing set points during unoccupied times, and turn off equipment not needed during unoccupied times.

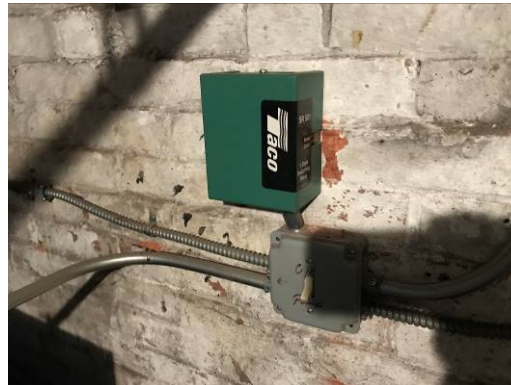
Boiler Pump Relay
